# ASSUNPINK DAM NO. 18 NJ 00452

## 6 PHASE 1 INSPECTION REPORT NATIONAL DAM SAFETY PROGRAM.

Assunpink Dam, Number 18 (NJ 00452).  
Delaware River Basin. Assunpink Creek,  
Monmouth County, New Jersey. Phase 1  
Inspection Report.

ASSUNPINK DAM NO. 18 (NJ00452)

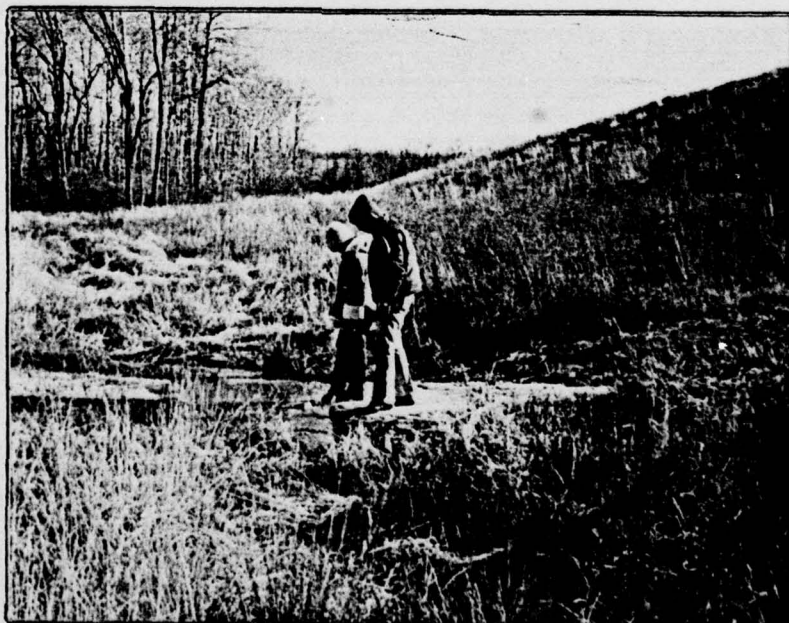
Stream at toe of right embankment

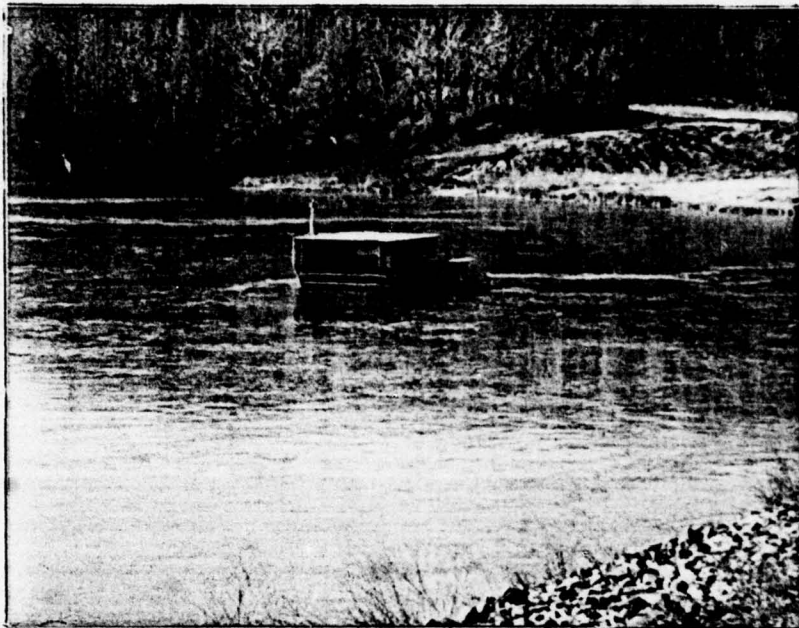
Intake structure

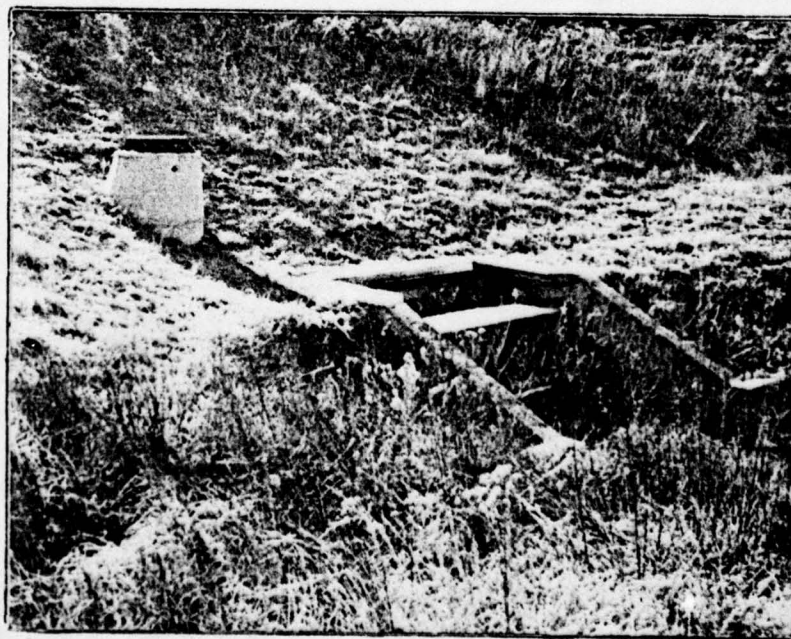
The main spillway riser tower and outfall are located roughly 380 feet from the left abutment. The upper portion of the reinforced concrete riser and the impact basin are in good condition. There are clear trash racks at each opening and the stem-operated gate is in good working order. There is some erosion just below the downstream wingwalls of the impact basin and earlier erosion pockets have been backfilled with riprap.

Outlet structure

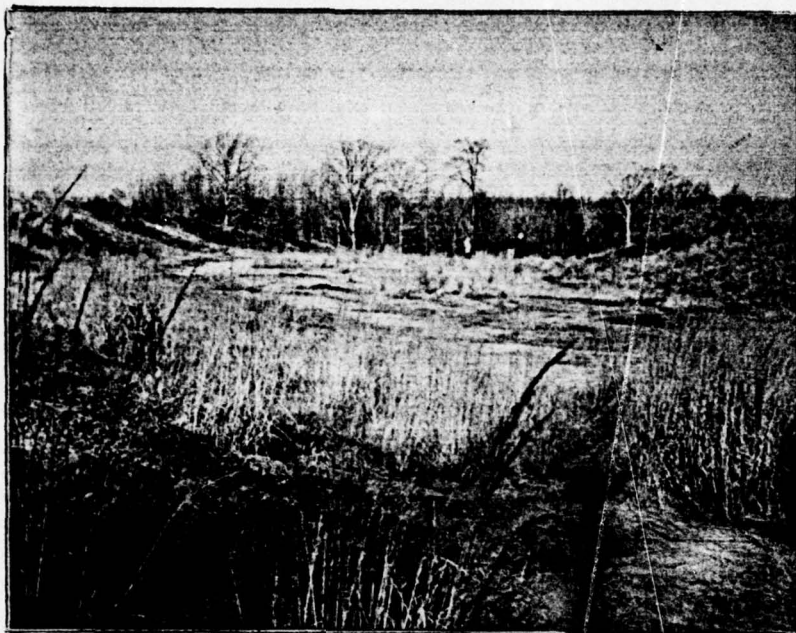
Auxiliary spillway

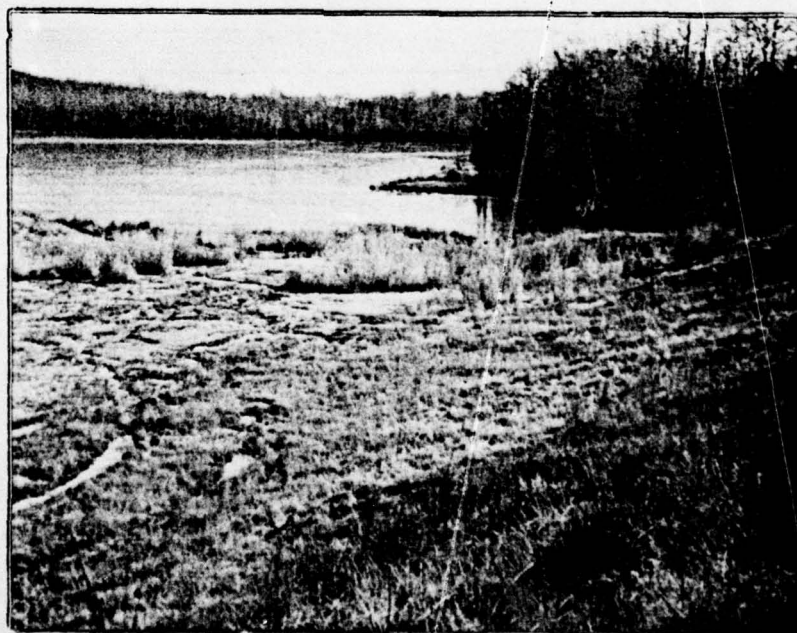
Auxiliary spillway inlet

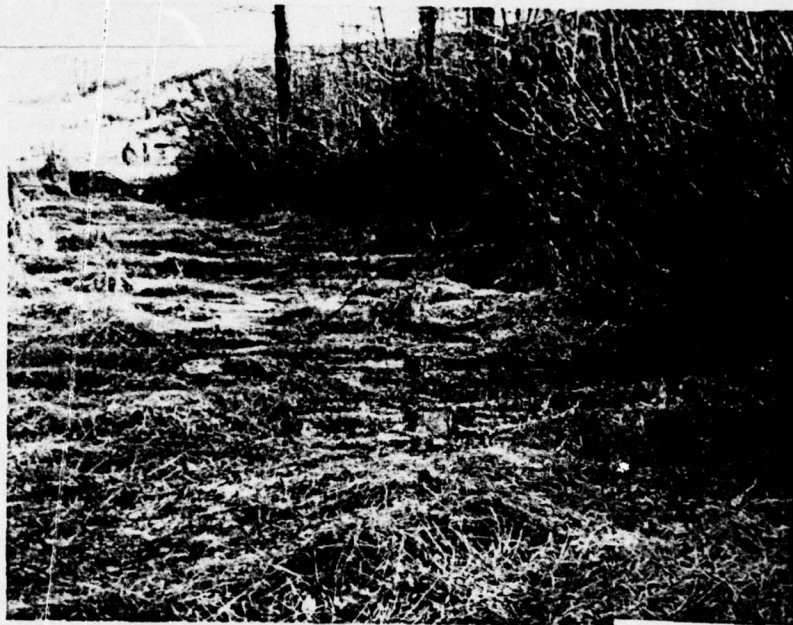
The embankment is a slightly curved structure lying between two naturally higher abutment zones on each side of the river channel. The plans indicate a three-zoned embankment to which riprap has been added on the upstream face. The slopes have a fairly continuous cover of grass but there are bare areas where unauthorized vehicular traffic has rutted the 15-foot wide crest and side slopes and caused erosion. Near the left end of the dam, the back slopes blend into the natural higher terrain which is covered by brush and numerous trees (up to 14 inches in diameter). There is an extensive wet area beyond the toe of slope and upward seepage was observed. Seepage was also observed in an area below the spillway outfall. The toe drain outlet pipes were flowing freely. SCS engineers informed the inspectors that several years ago seepage was noted near the top of the outfall wings, which necessitated the installation of additional sub-surface drains in order to lower the phreatic level. An orange precipitate (iron sludge) is continuously being formed in the drains. This appears to be of a substantial amount and occurs naturally at this site. Seepage was further observed in the natural higher ground beyond the auxiliary spillway (near the left abutment) and apparently is percolating through the permeable natural soils in this area.

Seepage at toe of left embankment

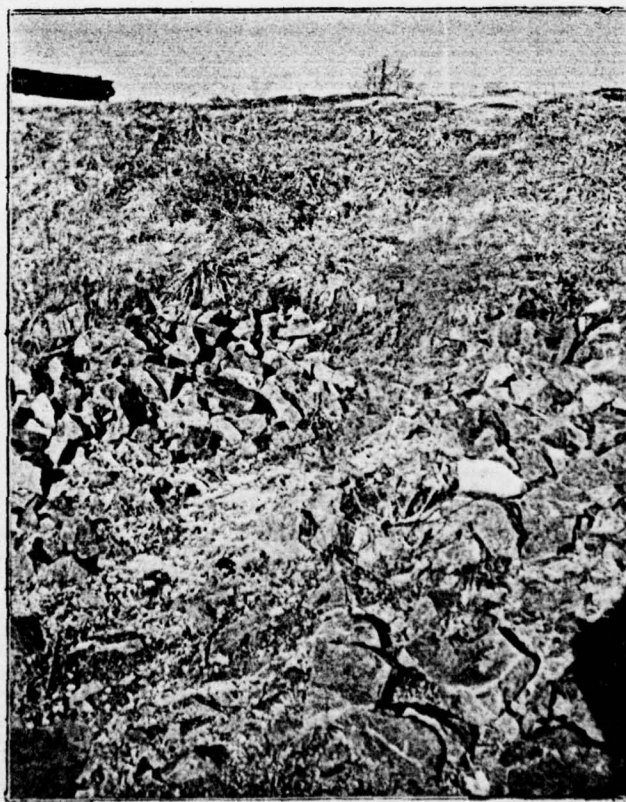
Although there are no major undercut areas, the vehicular traffic has done considerable damage to the graded slopes and in one area, a dirt road has been actually established due to the repeated usage. Numerous patches of "ice flowers" were noticed on the frozen backslopes but these are most probably caused by recent rains rather than deeper, subsurface seepage. Riprap has been displaced on the upper zone of the foreslope directly opposite the deepwater intake.

Displaced riprap directly opposite intake structure

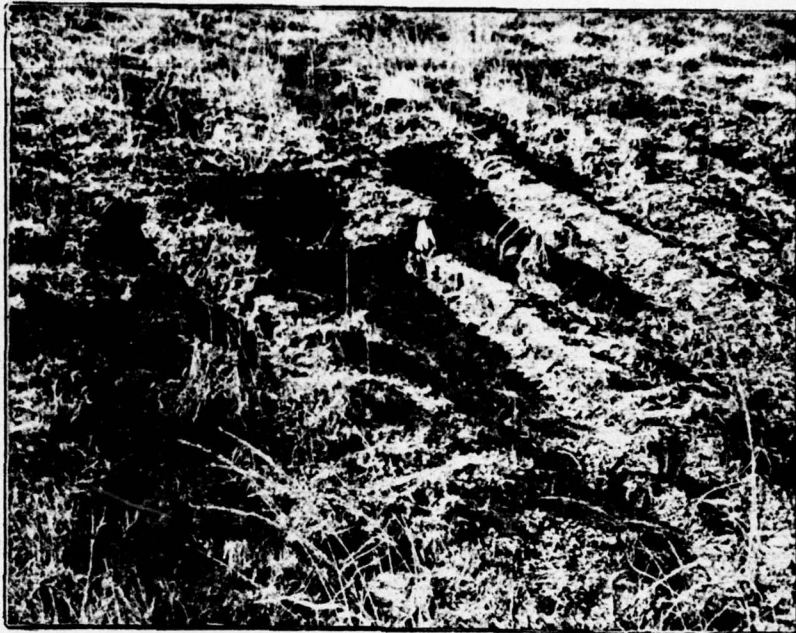
Minor erosion on surface of  
downstream embankment. Some  
caused by tire ruts.

Erosion of auxiliary spillway embankment

- a. Repair and seed eroded areas on all slopes.
- b. Place additional barriers at access points around the perimeter of the dam in order to prevent erosion caused by unauthorized vehicular use of the dam surfaces.

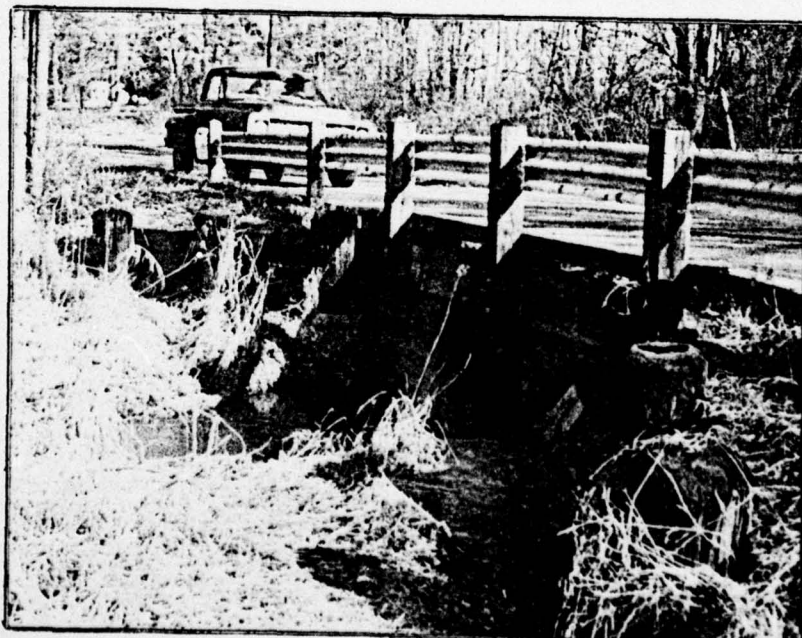
Bridge downstream from dam
